DOCKING REPORT MANUAL

Guide To Fouling Organisms and Instructions Regarding The Docking Report

Bureau of Ships
Navy Department
Washington, D. C.

1942

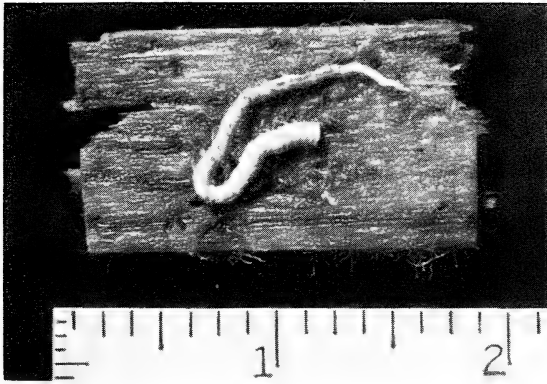
Fig. 1. Annelid.

These organisms can be readily recognized by their hard tubular shells (figs. 1 and 13), each of which houses a living worm. Sometimes the whole shell adheres firmly to the hull, but it may rise from the surface and stand out at a sharp angle. These tubes range in length from a fraction of an inch to several inches, and may form a large proportion of the fouling, especially on ships which have been stationed in the Hawaiian Islands or the southern Pacific. Some of the commonest forms have the scientific name of *Hydroides*. This should not be confused with Hydroids, the common name of an entirely different group of animals.

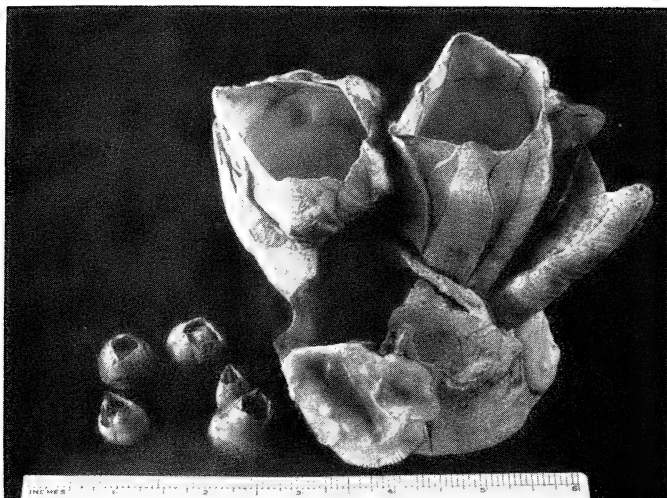
Fig. 2. Acorn Barnacles.

In many waters, Barnacles are the predominant form of fouling. Two general types are found. Acorn Barnacles (figs. 2 and 18) have a hard, conical shell which is made up of several distinct plates, and varies from a fraction of an inch to several inches in diameter at the base. The top of this cone is covered by four movable plates which may become detached when the animal dies. When the whole cone drops off or is re-

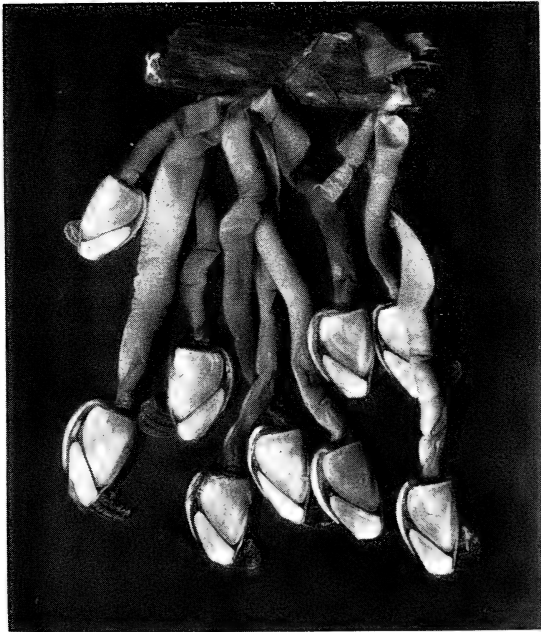
Fig. 3. Stalked Barnacles.

The other type of Barnacle is the Stalked or Gooseneck Barnacle (fig. 3). Whereas Acorn Barnacles are attached to the hull by the calcareous plates which form the cone-shaped shell, Stalked Barnacles have a muscular stalk which suspends the body from the hull. The body proper of both types is always protected by limy plates.

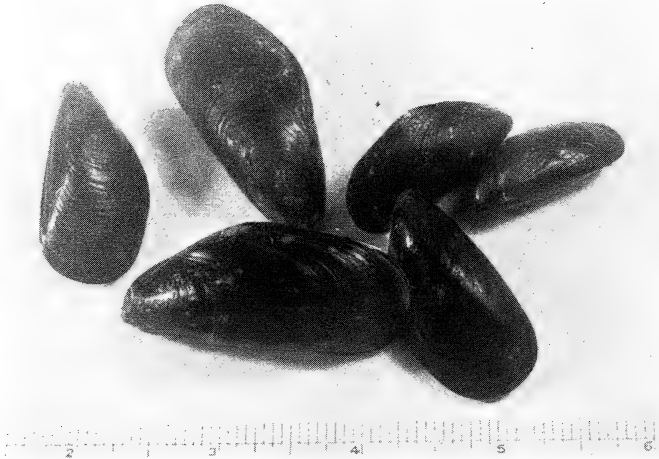
Fig. 4. Mussels (Mollusks).

This group includes the familiar edible clams, oysters, and mussels (fig. 4). All of the forms important in fouling are characterized by having paired or "two-valved" shells. They are generally attached to the hull at the region of the hinge of this double shell. Very many shapes are found, but all are characterized by this paired hinged shell, a structure not found in any other group of fouling organisms. Mollusks may grow to a large size, and since they may become attached to other Mollusks which in turn are attached to the hull, they frequently build up a large bulky mass of fouling.

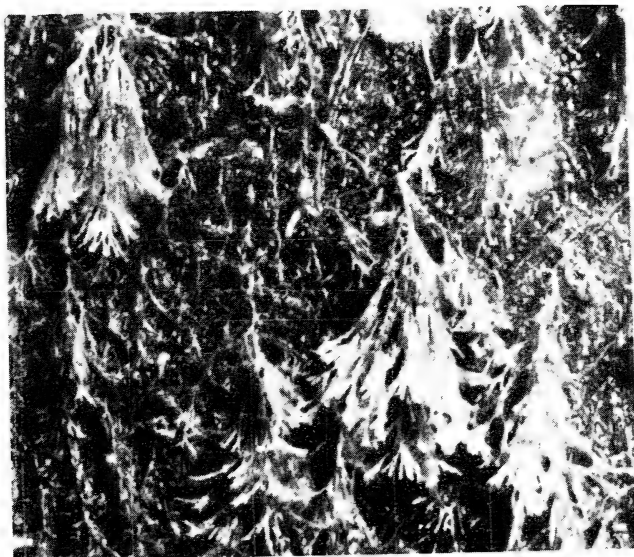
Fig. 5. Bryozoa (soft-bodied forms).

The Bryozoa include some soft-bodied, and some hard-bodied forms. Bryozoa are colonial animals, the colony being made up of hundreds or thousands of minute individuals. The colony may vary in appearance from a branching structure suspended by a single strand (fig. 5) to a moss-like mat of material or a thin encrusting growth (so-called coral patch) which spreads over a large area

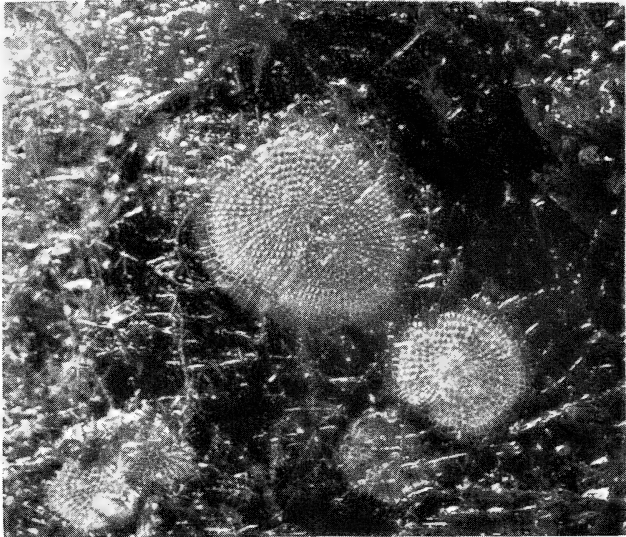
Fig. 6. *Bryozoa* (coral patches).

(fig. 6). When an adult Barnacle falls off the hull it generally leaves behind a circular patch or base plate. This may resemble a coral patch. The base plate of the Barnacle is marked by lines, whereas the coral patch is distinctly granular in appearance. The flat encrusting type of Bryozoa is frequently hard and calcareous, whereas the branching type is generally soft and flexible.

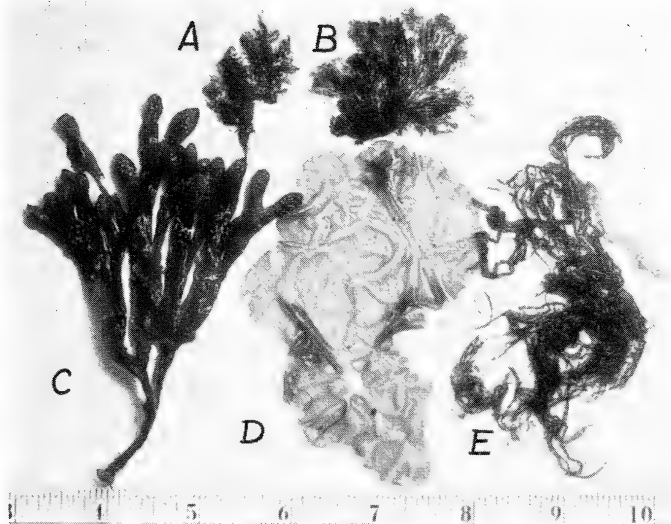
Fig. 7. Algae.

A, D, E, green algae; B, a red alga; C, a brown alga.

The characteristic fouling forms consist of mats of long slender threads or filaments, usually branched (fig. 7, A, B, and E). Others have fronds resembling ribbons or leaves of lettuce (fig. 7, D), and still others (known as rock-weeds) have hollow swellings which serve as floats (fig. 7, C).

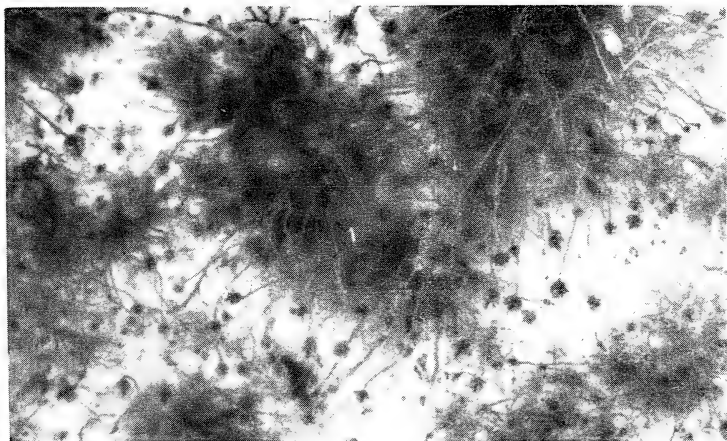
Hydroids (figs. 8 and 9) are small animals with slender stalks. Joined together like Siamese twins, they usually live in plantlike colonies composed of many individuals. Each branch of a colony represents a single individual. At the end of each branch is a flowerlike expansion, frequently pink in color. These expansions readily distinguish Hydroids from the branching types of Bryozoa. When attached to a hull, Hydroids often form a pale cream or tan mat which may be very thick and extensive.

Fig. 8. Hydroids, attached to a panel, normal size.

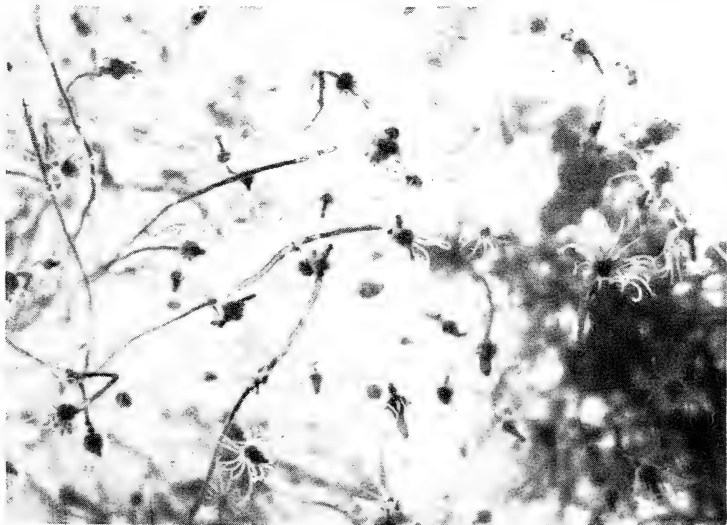
Fig. 9. Hydroids, enlarged.

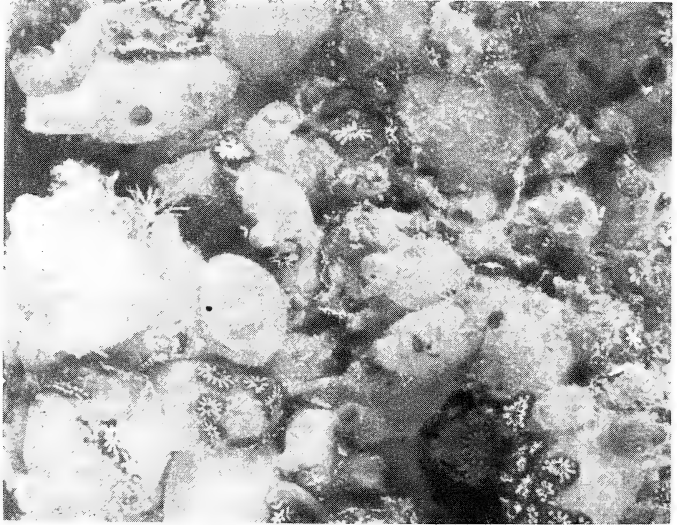
Fig. 10. Tunicates photographed under water.

Tunicates are soft-bodied, more or less leathery animals of various irregular shapes, often with a translucent covering (figs. 10 and 11). Each individual has two openings, one used as the intake and the other as the discharge for the sea water from which they sift their food, but as some kinds are colonial, a single mass may have more than one pair of holes. From their habit of expelling sea water, sometimes from both openings at once, these animals have also received the name of sea squirts.

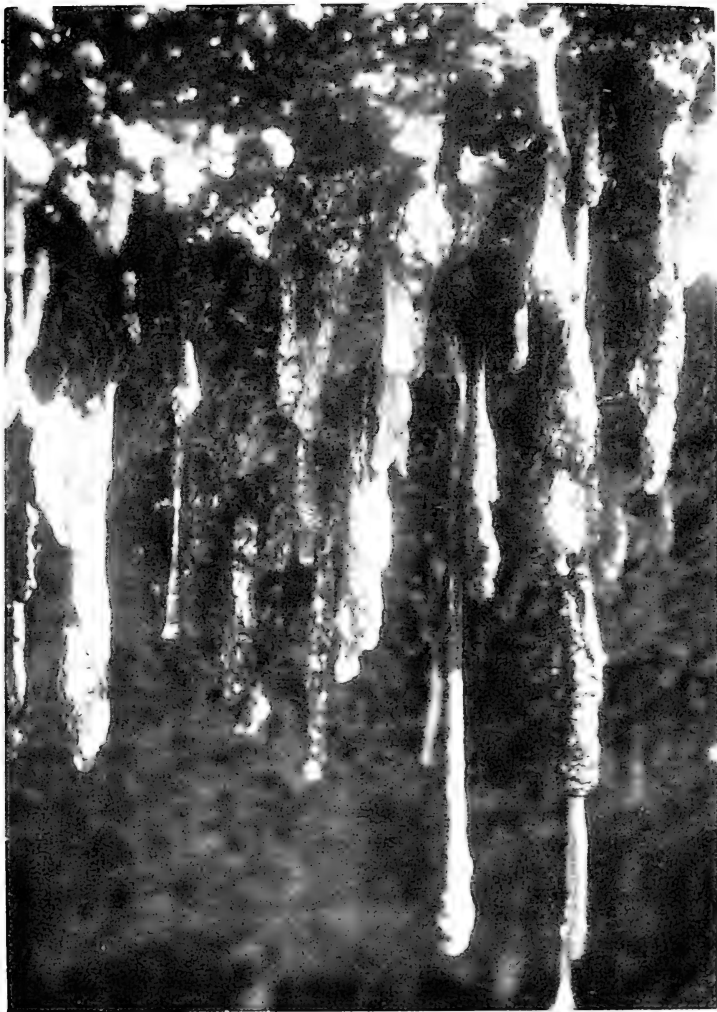
Fig. 11. Tunicates on an exposed hull.

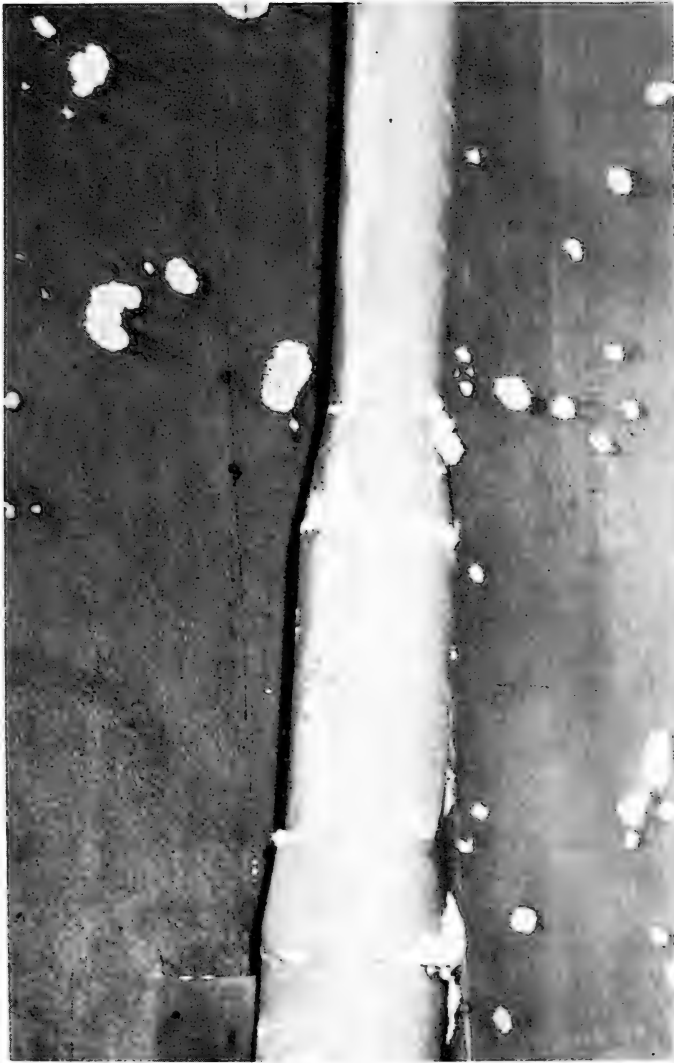
Fig. 13. Fouling in isolated small spots (note clusters of Annelids, common on ships stationed in tropical Pacific).

To aid in judging the extent of fouling, photographs showing all but "negligible" fouling are reproduced as figures 13-16. The grades established by these photographs may seem rather severe, but it should be emphasized that *any* fouling in a given area represents a partial failure of the paint. The percentage of film area that is ineffective is more important than the total weight or thickness of the fouling.

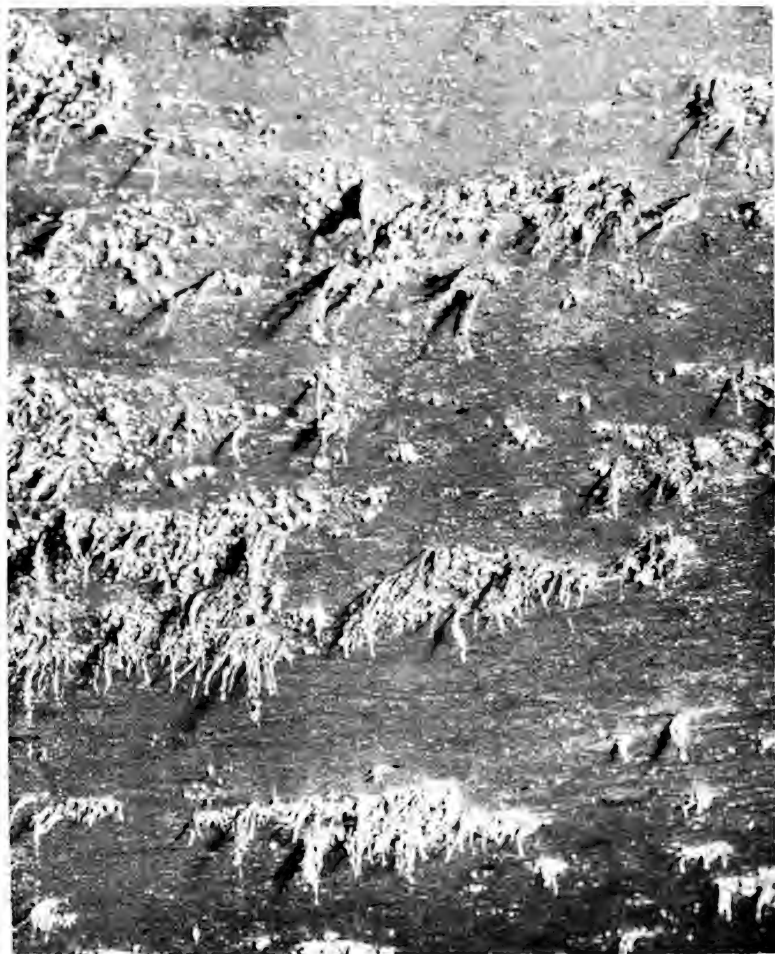
Fig. 14. Fouling (mostly Hydroids) in large patches.

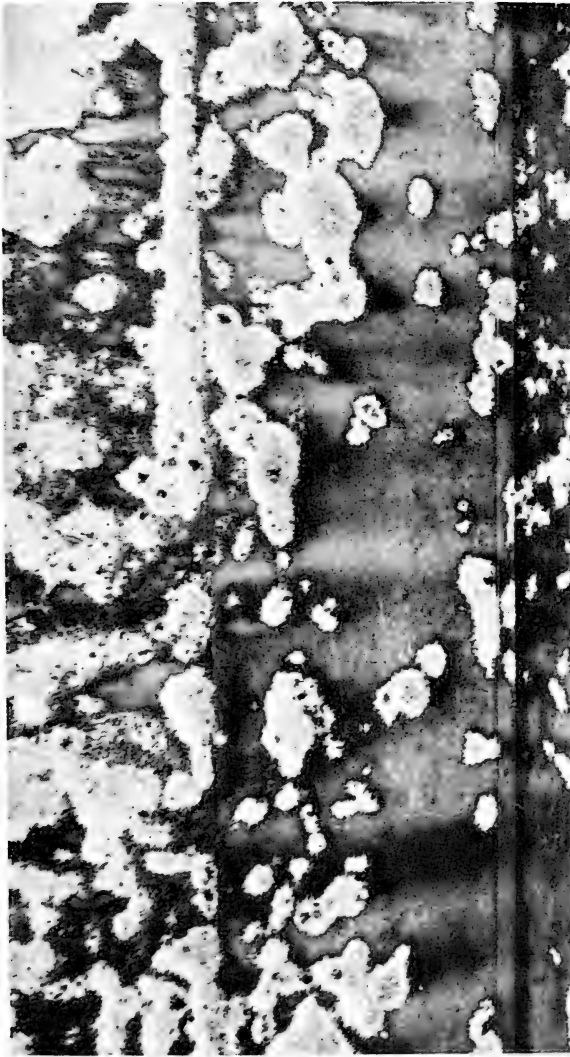
Fig. 15. Fouling (Annelids) covering larger part of area.

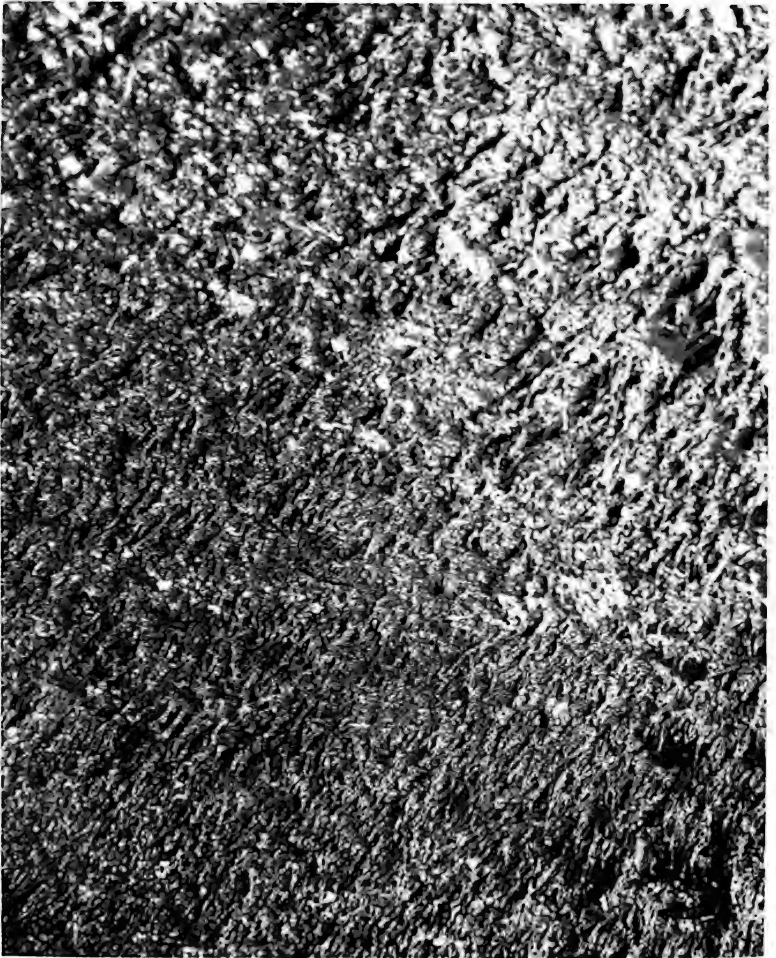
Fig. 16. Fouling covering area completely.

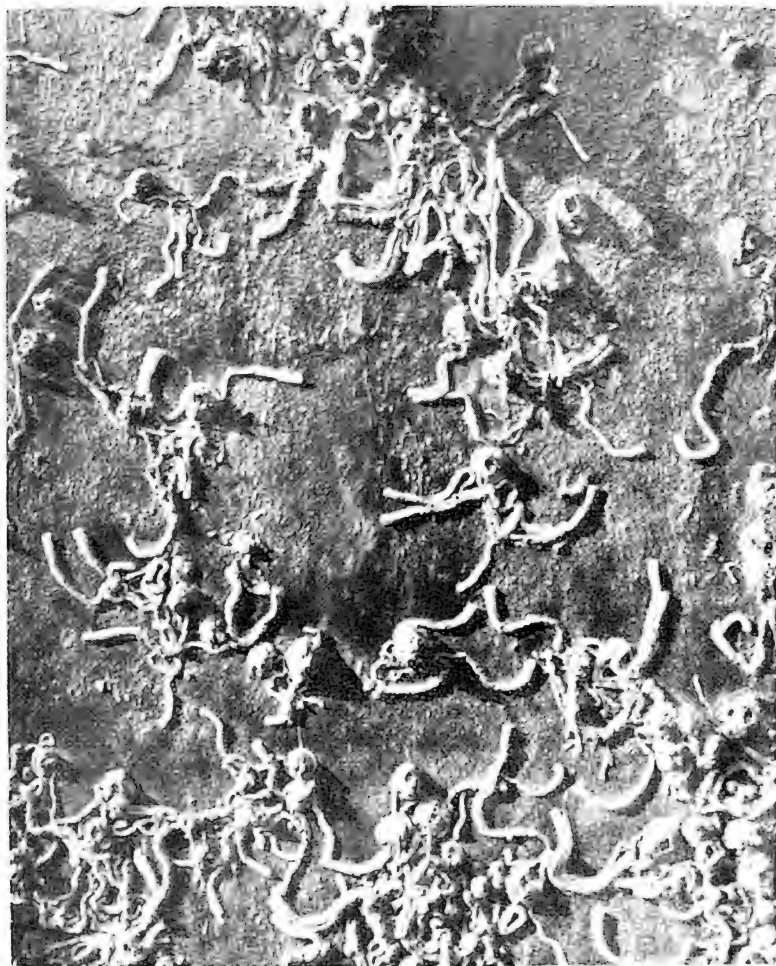
Fig. 17. Fouling organisms (Annelids and Barnacles) uniformly distributed. Corresponding to fouling distributed in large patches.

PERCENTAGE OF GIVEN AREA UNIFORMLY FOULED	CORRESPONDING GRADE OF "PATCHY" FOULING
0-5%	"negligible"
5-10%	"in isolated small spots"
10-20% (fig. 17)	"in large patches"
20-50% (fig. 18)	"covering larger part of area"
50-100%	"covering area completely"

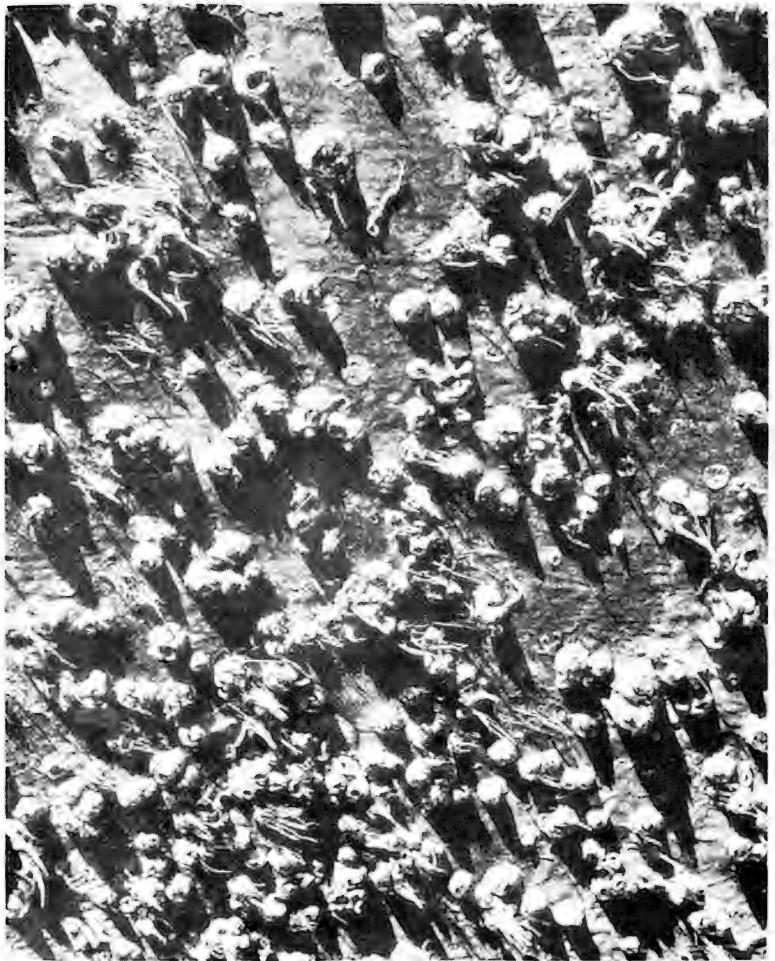
Fig. 18. Fouling organisms (Barnacles with Bryozoa and Annelids) uniformly distributed. Corresponding to fouling covering larger part of area.

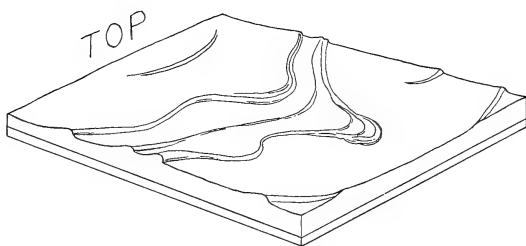
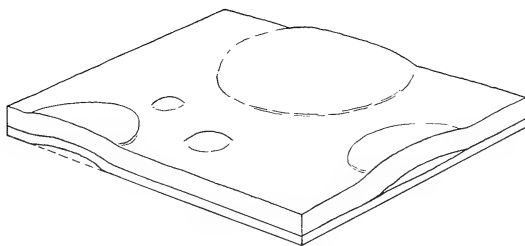
Fig. 19. Types of paint failure.

SAGGING

BLISTERING

⑯ Submit photographs of special or unusual conditions if possible. See figs. 19-20.

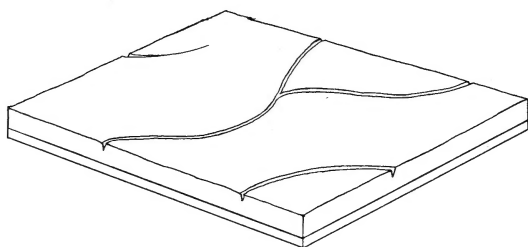
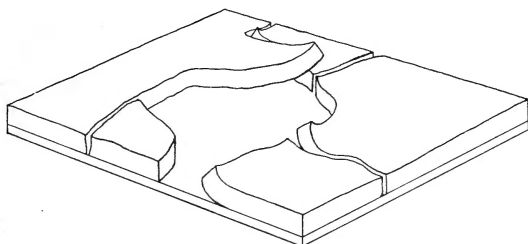
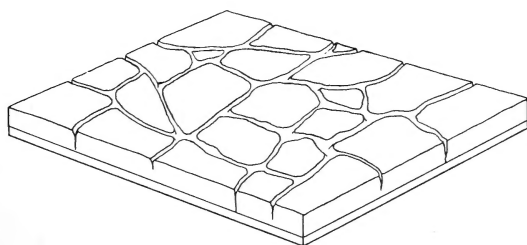
Fig. 20. *Types of paint failure.*

CHECKING (*surface cracking*)

CRACKING and PEELING

ALLIGATORING
